BUILDING-STRUCTURE INVENTORY FORM

1. BUILDING NAME(S): Castle - Smith House
2. COUNTY: Monroe TOWN/CITY: Greece VILLAGE: ---
3. STREET LOCATION: 706 Manitou Road (S.E. Corner of Frisbee Hill Rd.)
4. OWNERSHIP: a. public ☐ b. private ☒
5. PRESENT OWNER: John & Linda DeRue ADDRESS: (same) Hilton, NY 14468
6. USE: Original: residence/farm Present: residence
7. ACCESSIBILITY TO PUBLIC: Exterior visible from public road: Yes ☒ No ☐
Interior accessible: Explain private residence

19. DATE OF INITIAL CONSTRUCTION: c. 1872
ARCHITECT: not determined
BUILDER: not determined

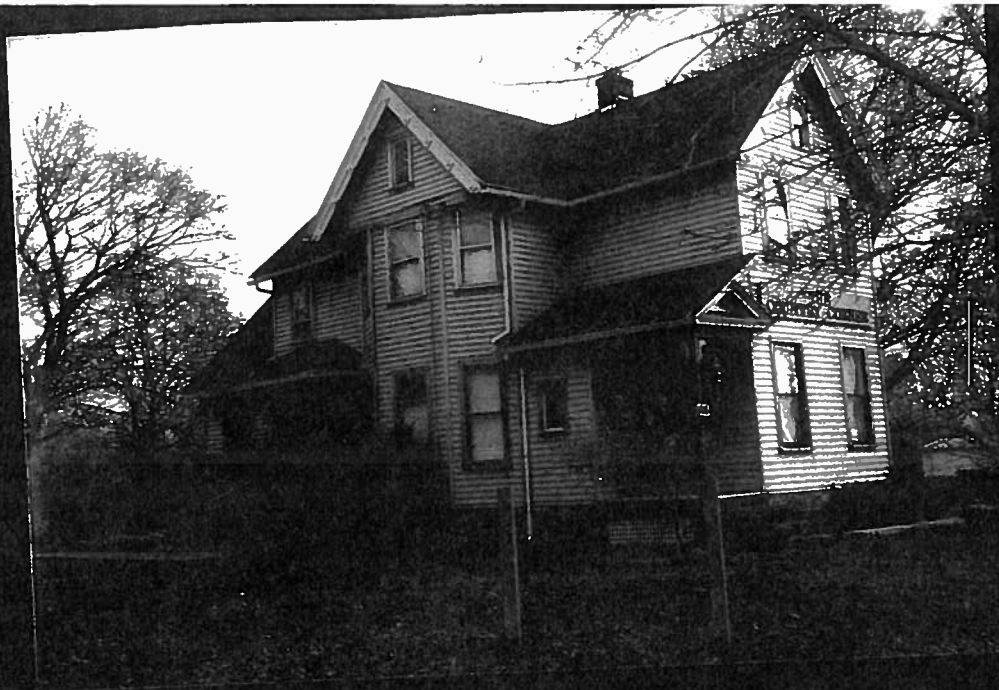
12. PHOTO:

18. The Castle-Smith House is a two-and-one-half-story, cross-gabled, vernacular Queen Anne farmhouse. This vinyl-sided frame house is constructed atop a pargeted fieldstone foundation. A brick chimney is located atop the main ridgeline of the roof. Fenestration is regular and repetitive with 1/1, double-hung wood windows. Each of the cross-gabled sections is two-bays wide. The north gable features a two-story, cutaway, window bay. The front gable has a round-arched window; the north and south gables have rectangular windows with decorative, colored glass. The north, west and east gables include wide, decorative bargeboards with alternating recessed panels and raised circular designs.
